Technical Report ARFSD-TR-94021

M864 CARGO EXPULSION FAILURE INVESTIGATION

March 1995

U.S. ARMY ARMAMENT RESEARCH, DEVELOPMENT AND ENGINEERING CENTER

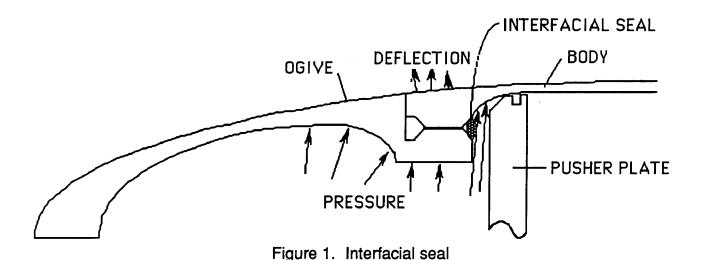
An interfacial seal (fig.1) was formed by applying Loctite's Ultrablue 587 to the interior surface of the body-ogive joint. This sealant adds no radial strength to the joint, but does seal the joint from the expulsion gasses. The ultrablue was selected because it is used on the weatherseal assembly in the base burner assembly. The sealant must be allowed to cure for 24 hrs before final assembly is initiated. The cost of the interfacial seal was estimated to be between \$4 (FY92) and \$5 (FY92) per unit.
